## **Year 11 → Year 12 Physical Geography Coasts Transition Task**

### Coastal management in Norfolk

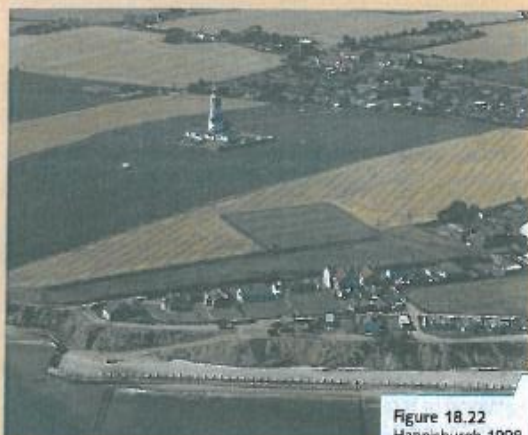
Figure 18.22  
Happisburgh 1998

century stone church, several listed buildings and a landmark red-and-white striped lighthouse (Figure 18.22). Although it is now a coastal village, it was once located inland, being separated from the sea by Whimpell, a settlement that has long since been lost to the sea. Records for Happisburgh show that between 1600 and 1850 erosion by the sea resulted in the coastline retreating by over 250 metres. Attempts were then made to prevent further loss and these seem to have at least slowed down the rate of retreat. However, a lack of maintenance has led to the defences falling into disrepair and erosion to accelerate. The soft cliffs, varying in height between 6 and 10 metres, have retreated by 100 metres in the ten years since 1998 (compare Figures 18.22 and 18.23). This retreat is resulting in the loss of at least one property per year and considerable amounts of good agricultural land. The inhabitants of Happisburgh, naturally, want new sea defences built to protect their property despite the enormous costs that this would involve.

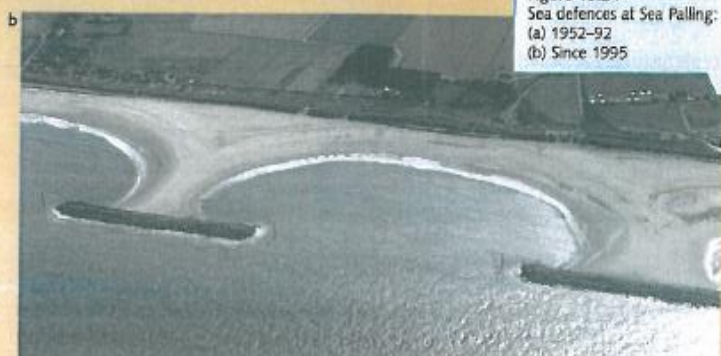
Figure 18.24  
Sea defences at Sea Palling:  
(a) 1952–92  
(b) Since 1995

At Sea Palling the beach is backed by sand dunes which, in earlier times, helped to provide a natural defence.

The strategy was implemented by placing 150 000 tonnes of rock in front of the sea-wall, replenishing the beach with nearly 1.5 million cubic metres of sand and – the major part – constructing four offshore reefs. The reefs were designed to protect the beach by reducing wave energy while at the same time allowing some longshore drift so as not to deplete the supply of sand to beaches further along the coast (Figure 18.25).

Almost immediately after their completion in 1995, a previously unpredicted problem arose: that of sand accumulating in the sheltered areas behind the reefs. This meant that the reefs became joined to the mainland (Figure 18.24b), which in turn interrupted
